***United States Court of Appeals
for the Second Circuit***

HELLENIC LINES LIMITED,

LIFE INSURANCE CORPORATION OF INDIA,

EXHIBIT VOLUME

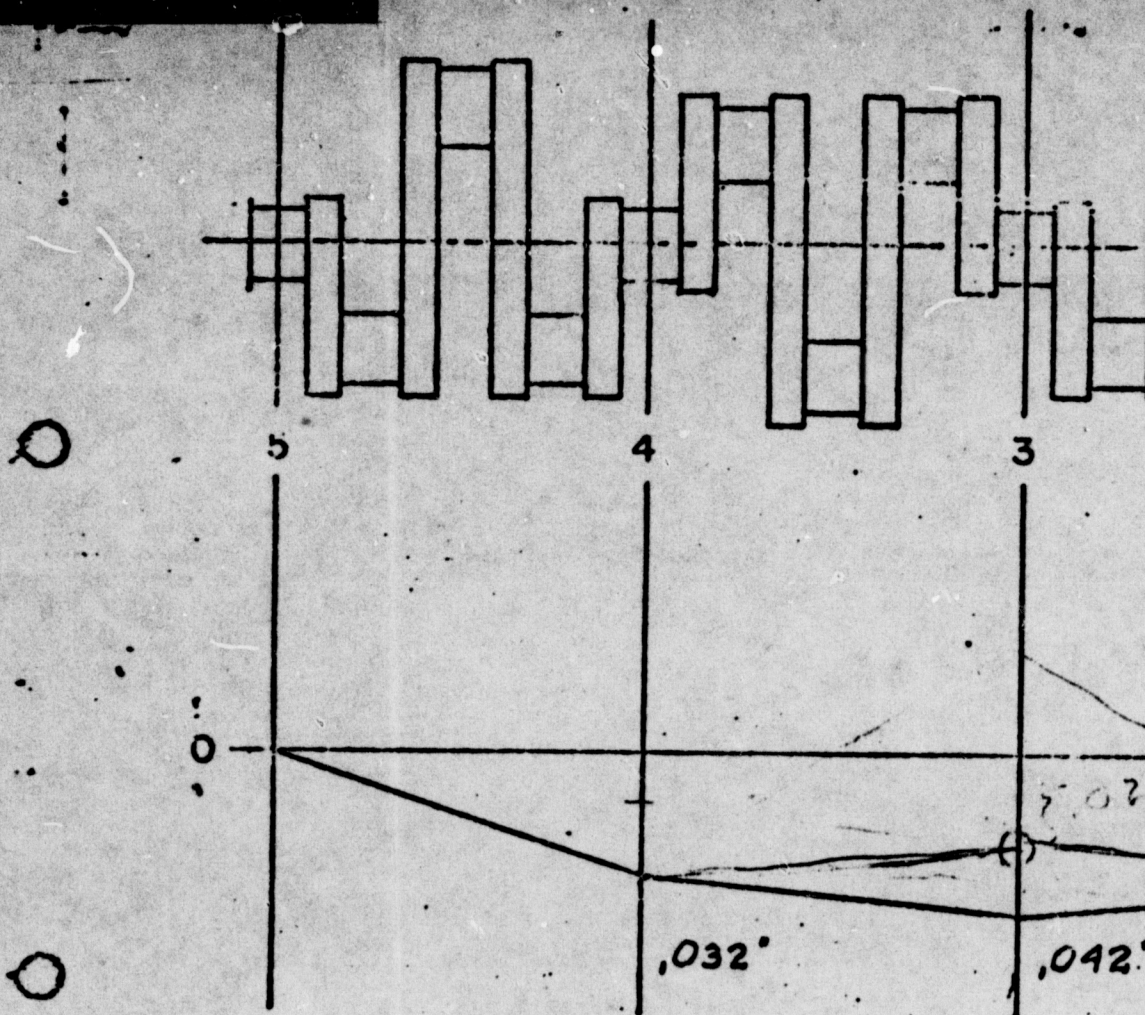
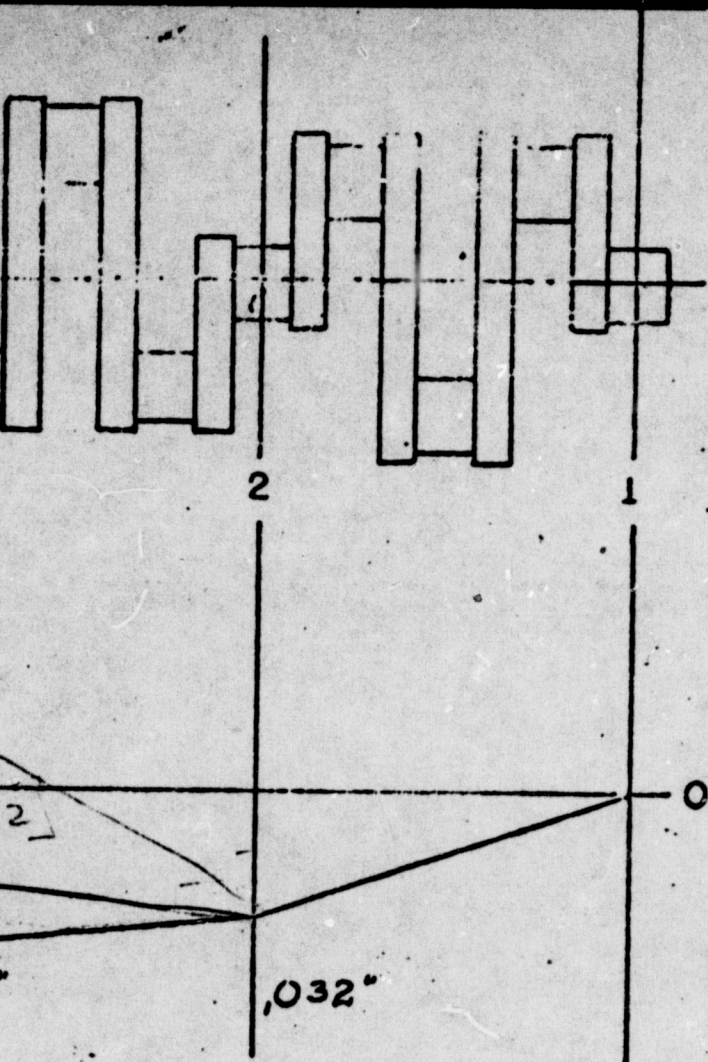
WIRE-GAGE-READINGS ALONG
CRANKSHAFT ON DOXFORD ENGINE

Enclosed herewith please find your file copy of pilgrim wire readings as taken while your ship was at our port. Please note the position of the crankshaft, with Nos. 2, 3 and 4 below the "0" line. It is important to observe the ship's draft while the readings were taken and with 12'6" forward the ship would be in a comparatively light condition causing the deflection to be below the "0" line, although the figures show an excess over the desirable measurements.

We will take further readings at the next available opportunity with the ship in both loaded and light conditions.

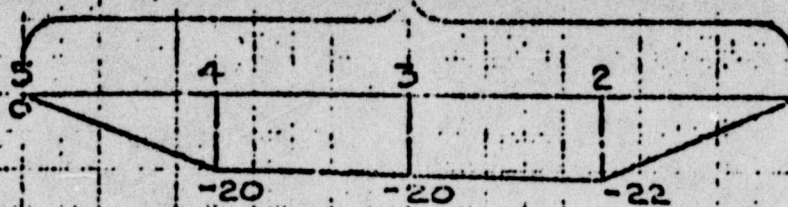
FIG. 1(a)

...combined alignment of the crankshaft and intermediate shafting and this is obviously unsatisfactory. In this particular case, trouble had been experienced with excessive main bearing wear and remedial action consisted of re-chocking the engine so as to lower the forward end. The final result achieved was as shown by the broken line in Fig. 1(b) in which condition the main bearing difficulties ceased. The particular example quoted obviously represents an extreme case, the defective alignment condition having almost certainly been brought about by grounding of the vessel (damage to the ship's structure was not readily apparent and the effect on the engine was hitherto unsuspected) but it is used as an illustration of the principle concerned.

VESSEL A - ALIGNMENT OF CRANKSHAFT ONLY.

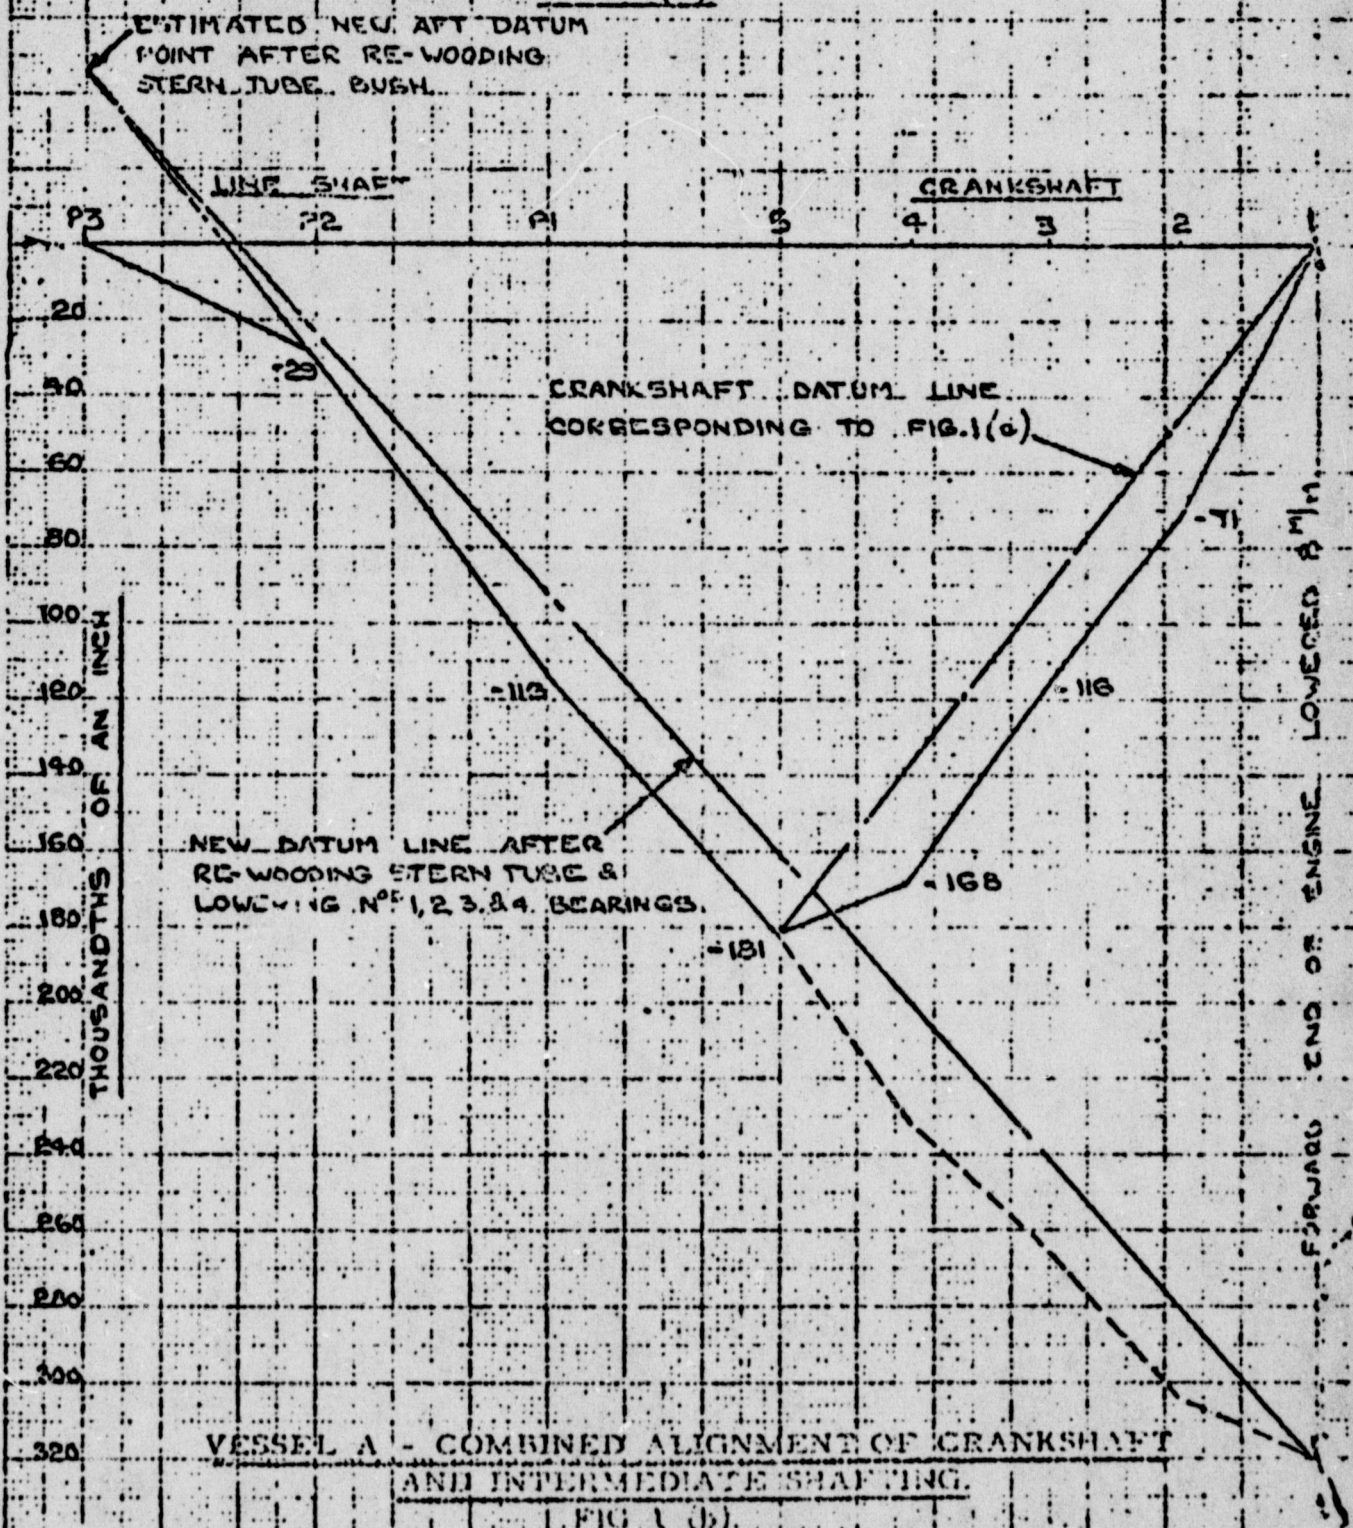
FIG. 1 (b).

VESSEL A - COMBINED ALIGNMENT OF CRANKSHAFT AND INTERMEDIATE SHAFTING.

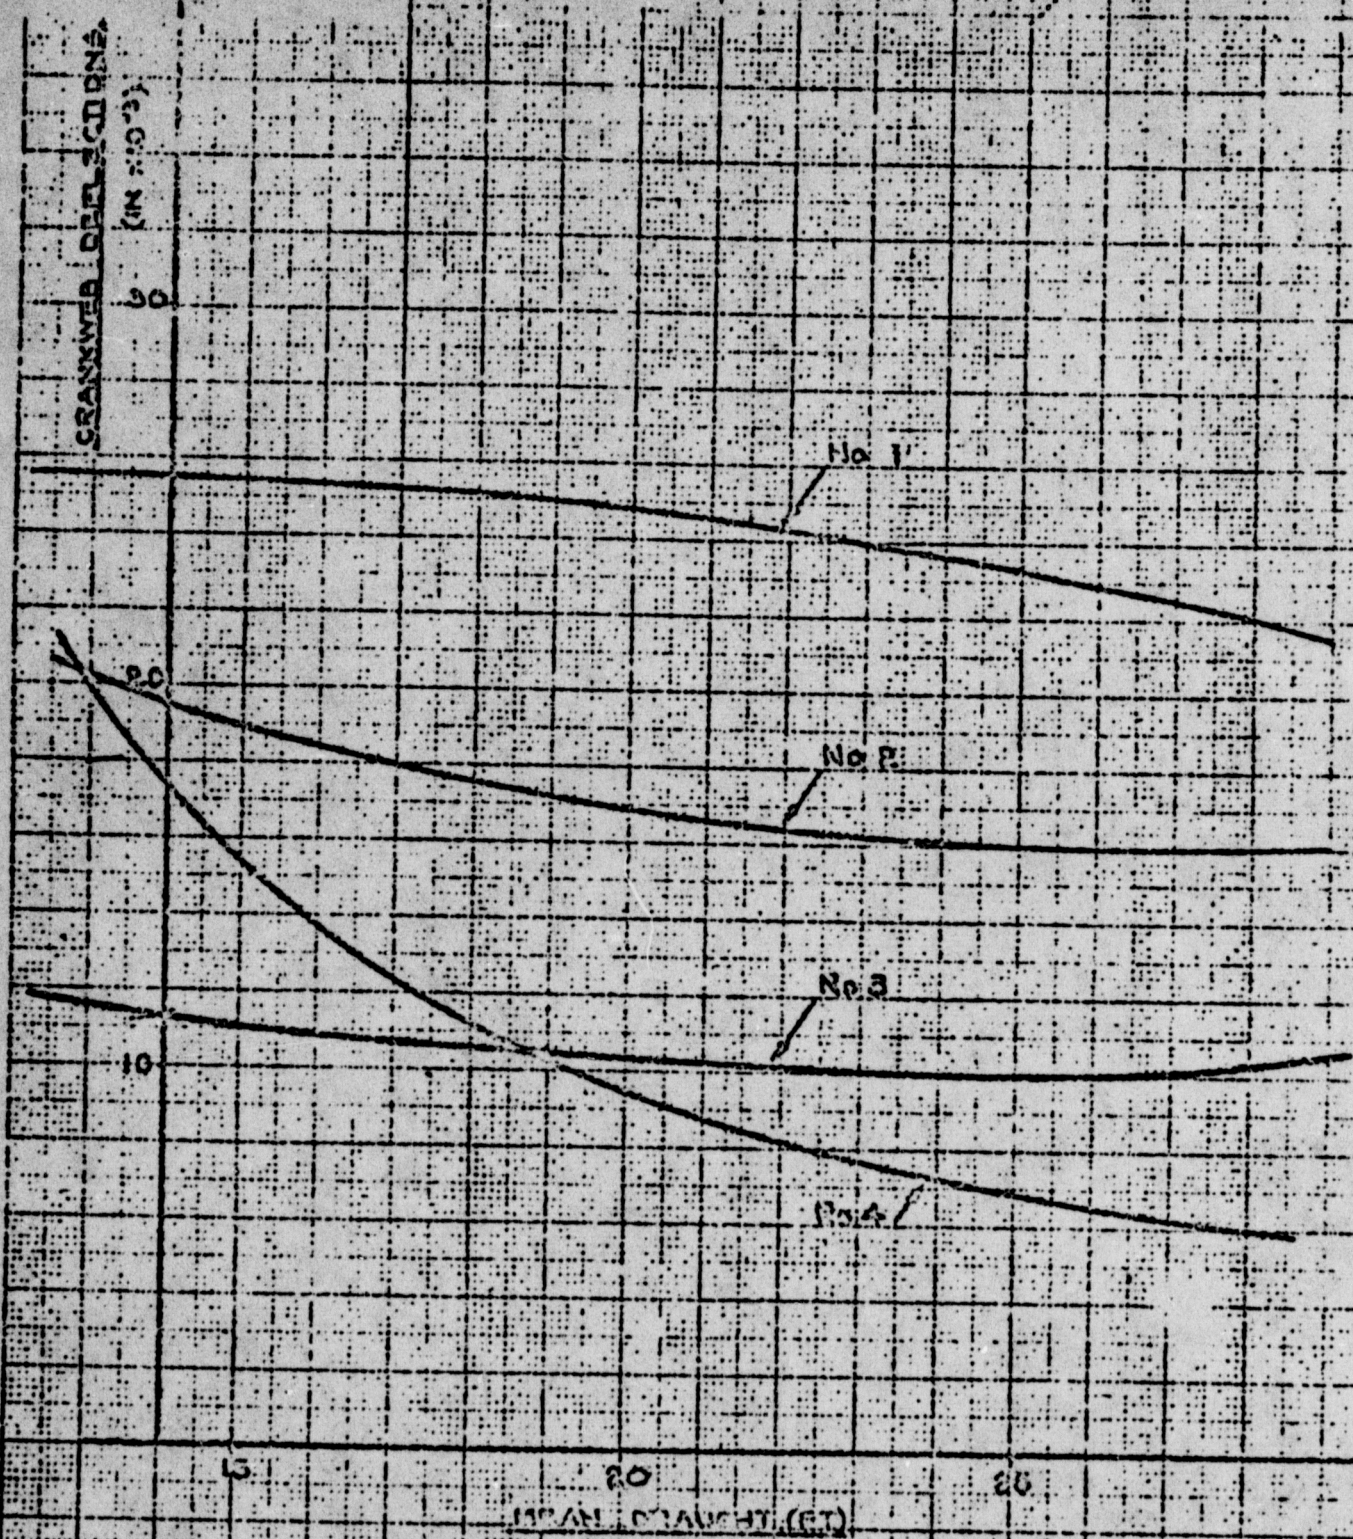
FIG. 7.

- (2) Changes in ship loading affect crankshaft deflections to some extent but mainly at the after end of the engine. In Fig.7 actual vertical deflections of all four cranks of a four cylinder engine are plotted against mean draught which forms a measure of the ship loading. These figures are taken from a typical dry cargo ship with engine amidships and it will be noted that the variation at No.4 centre crank is very much greater than at Nos. 1, 2 and 3. The ship loading condition should therefore be noted when considering the deflections of the aftermost cranks since, while a vertical deflection as low as .005 inches at this position may be perfectly acceptable when the ship is fully loaded (i.e. at maximum hog), the same reading is unsatisfactory when the ship is light due to the change which will occur during loading.

CRANK WEB DEFLECTIONS VERSUS MEAN DRAUGHT.

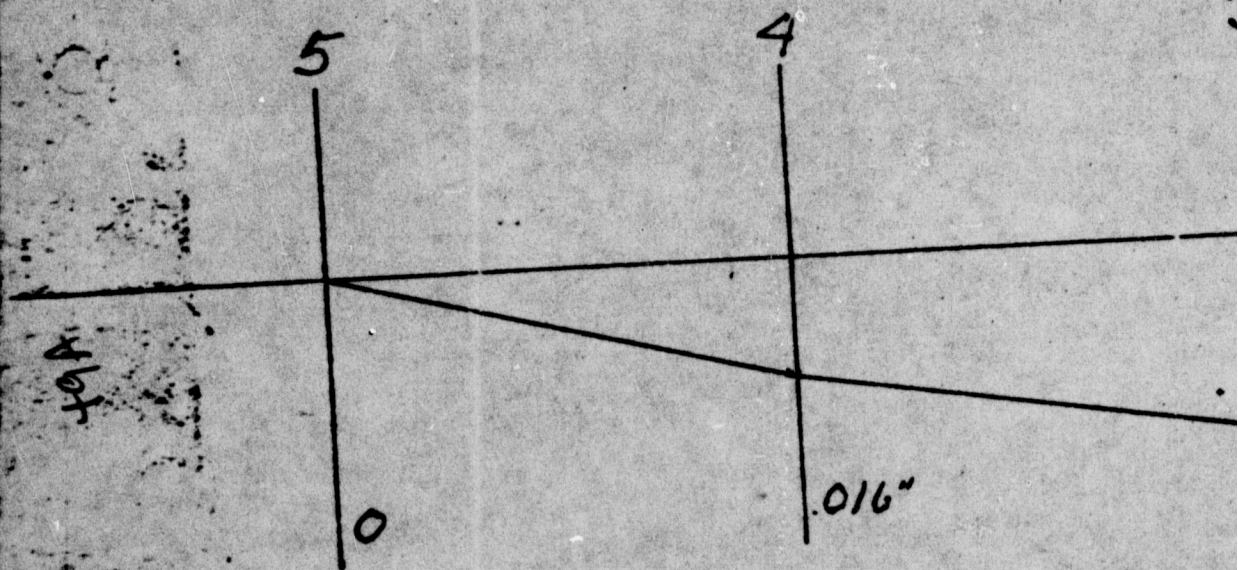
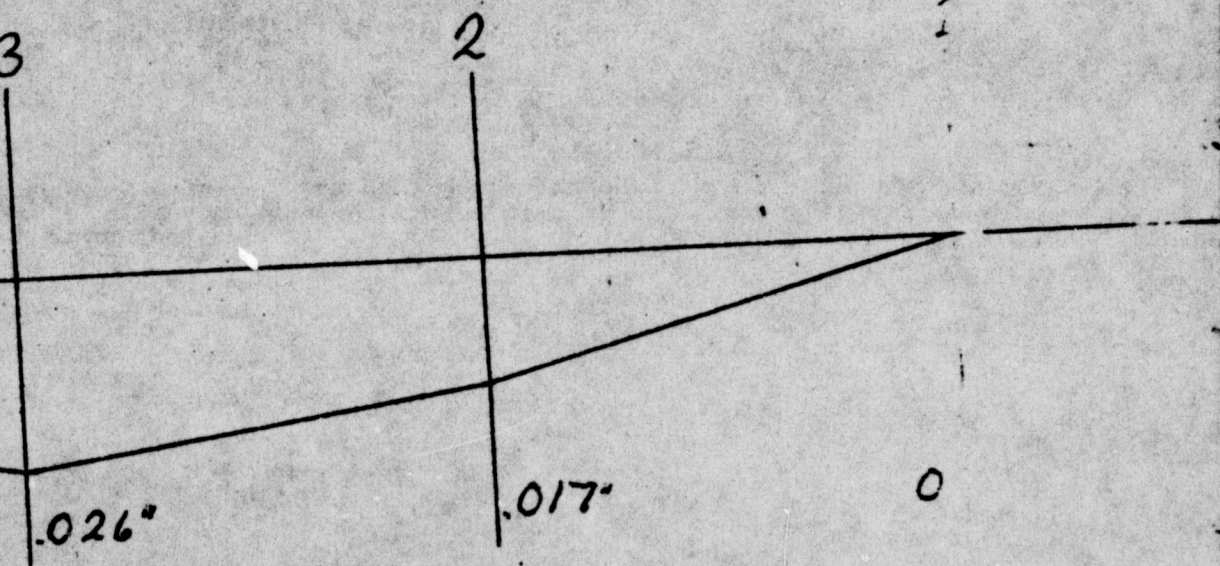
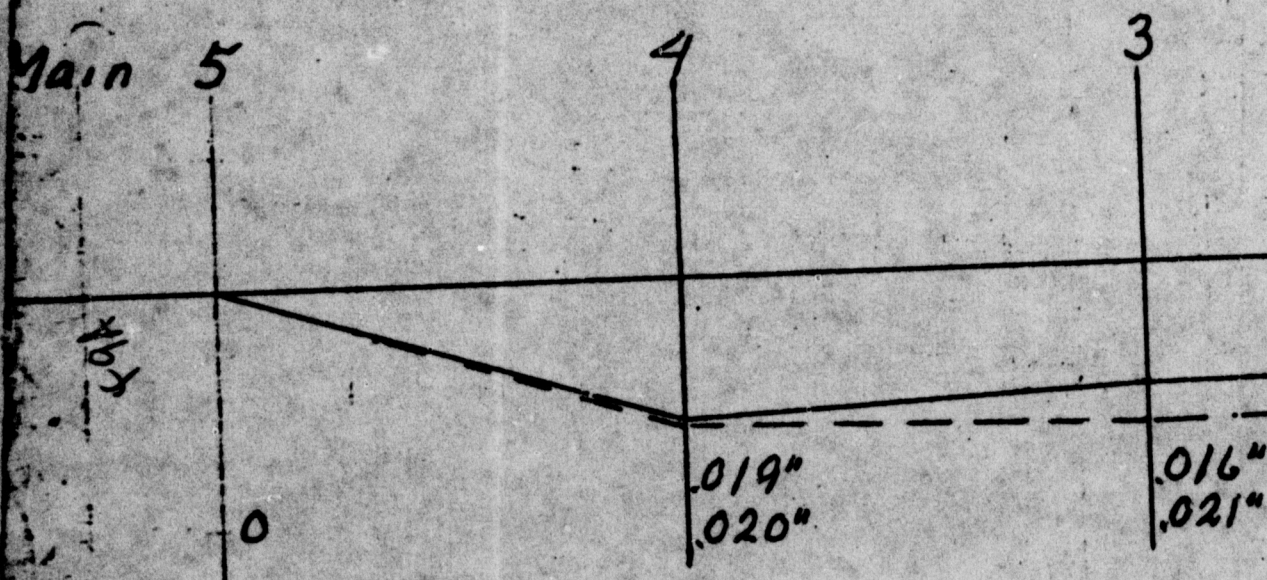
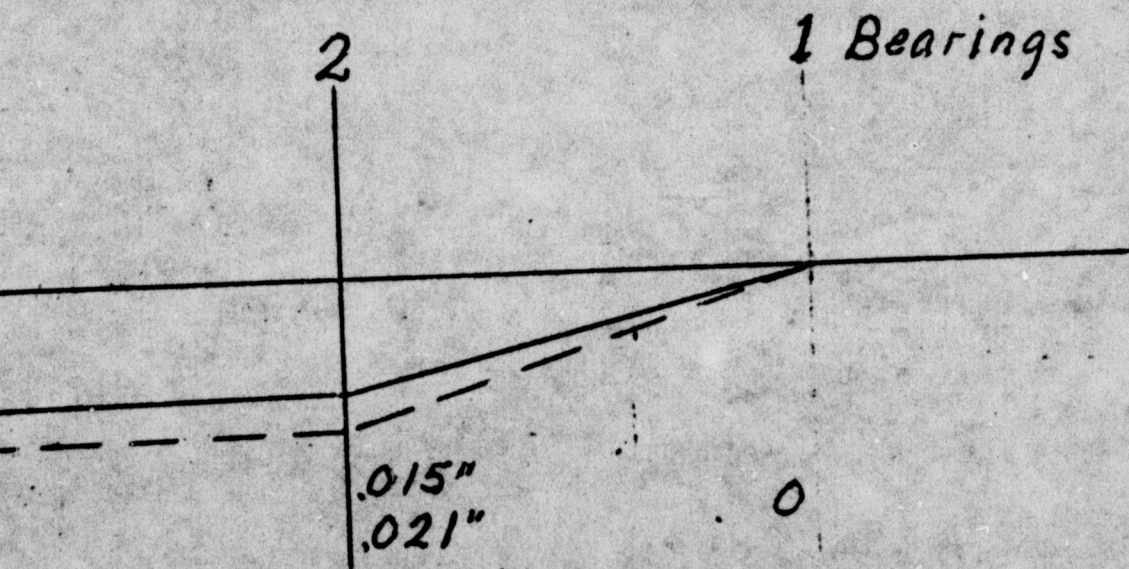
"S Hellenic Sailor" Port Sudan Feb -
M.E. Crankshaft Alignment checked
Pistons and connecting rods disconn
Dotted line reading with shaft pulled d

with K+E Transit
ected from No. 2 Cranks
own tight in No's 2 and 3 bearings.

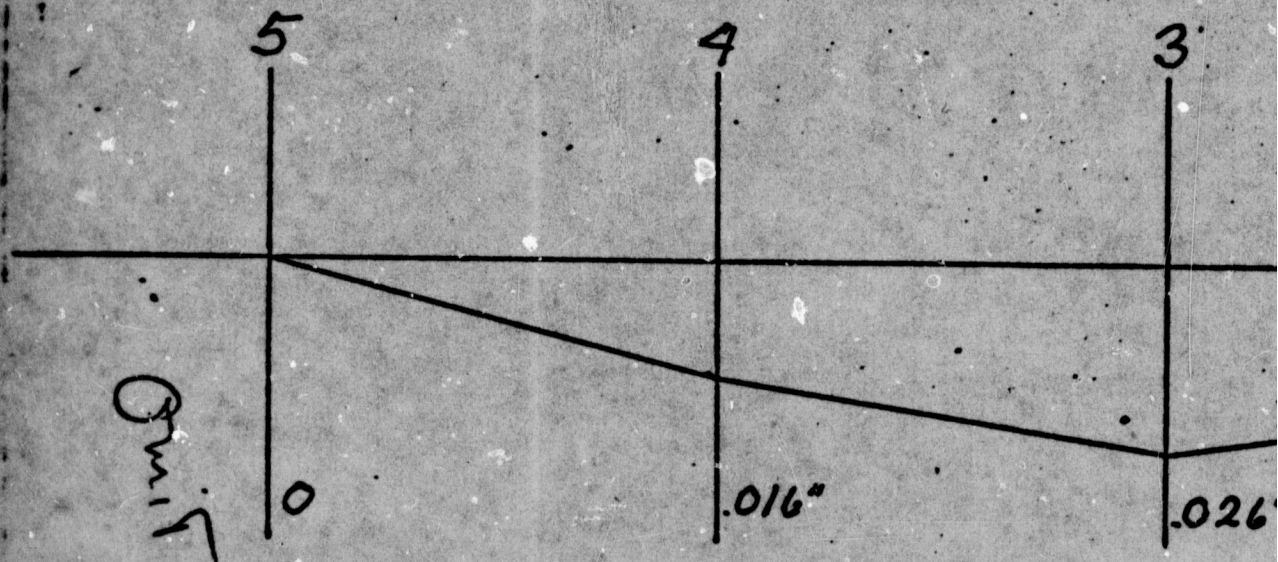
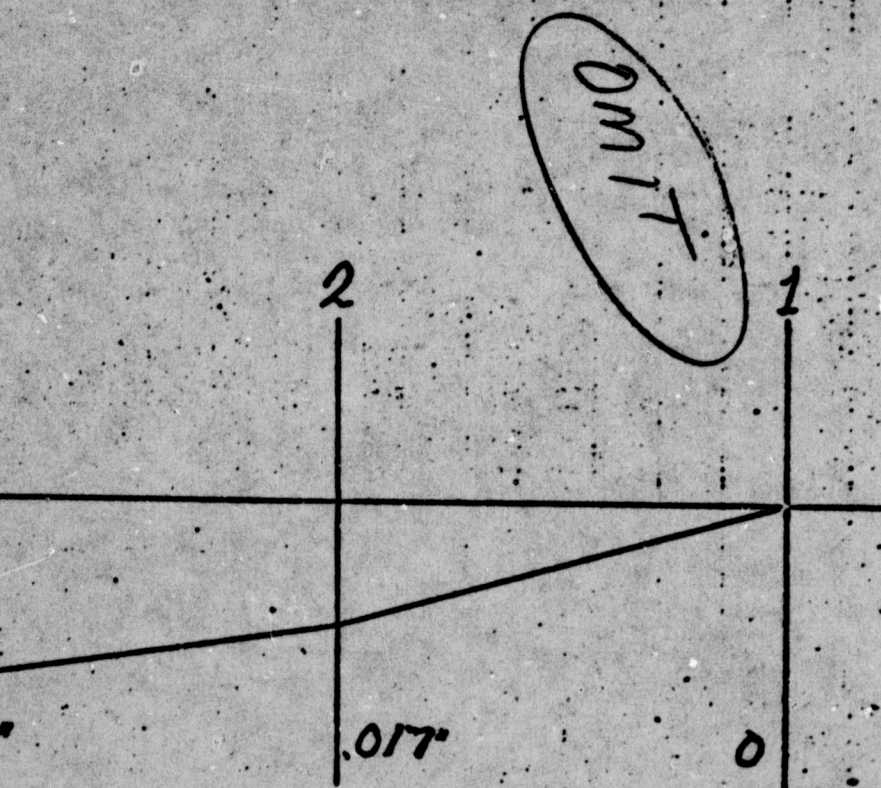
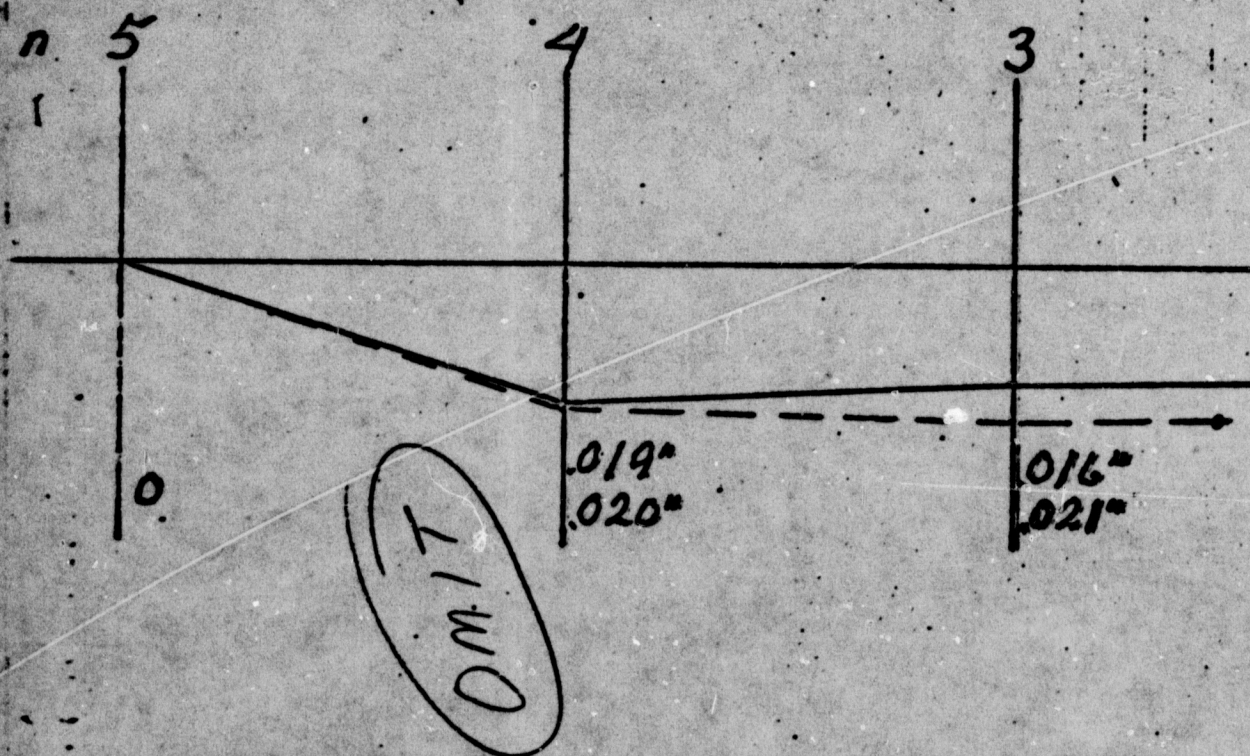
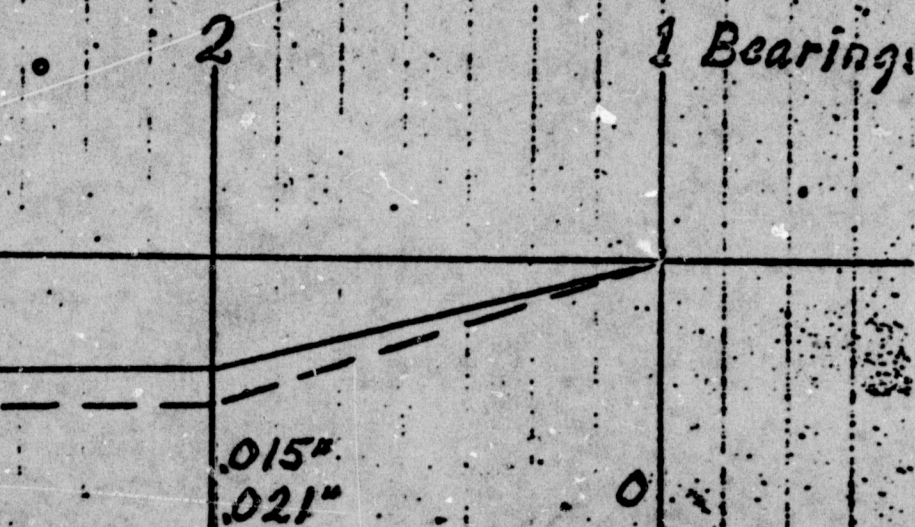
M.E. Crankshaft Alignment checked with
Pistons and connecting rods disconnected
Dotted line reading with shaft pulled down

th K+E Transit
ed from No. 2 Cranks
tight in No's 2 and 3 bearings.
